1 Preparations for firmware update of NFO Sinus Optimal

2 Firmware update procedure

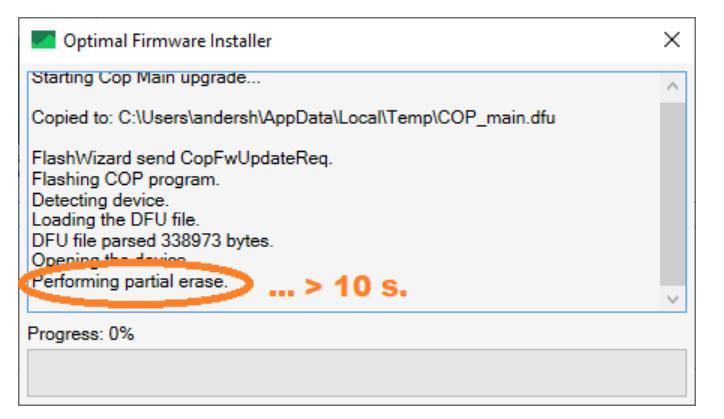
- One of the first parts of the firmware update procedure is to erase the flash memory of the Co-Processor. As mentioned at the beginning of this document, CPU's of a certain manufacturing period show a small chance to get stuck during erase. Normally the erase shall finish in about 5 seconds or less. If the CPU automatically moves on to Writing block# sequence, there is no problem. Then just continue to to section 4.
- If the text in the information box doesn't move on after 10 seconds or more, the erase function is stuck.

• Pull out the USB cable from computer, click **OK** if any error message appears.

- Close the Sinus Manager program (if it doesn't automatically close).
- Power off the inverter an let it black out.
- Start the Sinus Manager program again.
- Plug in the USB cable.
- Sinus Manager will now detect an inverter with incomplete installation. Click Yes to continue.
